Tree Inventory and Preservation Plan – (Sample) 10223 – 135 Street NW Edmonton, Alberta

October 23, 2021

Test Consulting Ltd.
ISA Certified Arborist PR-12345

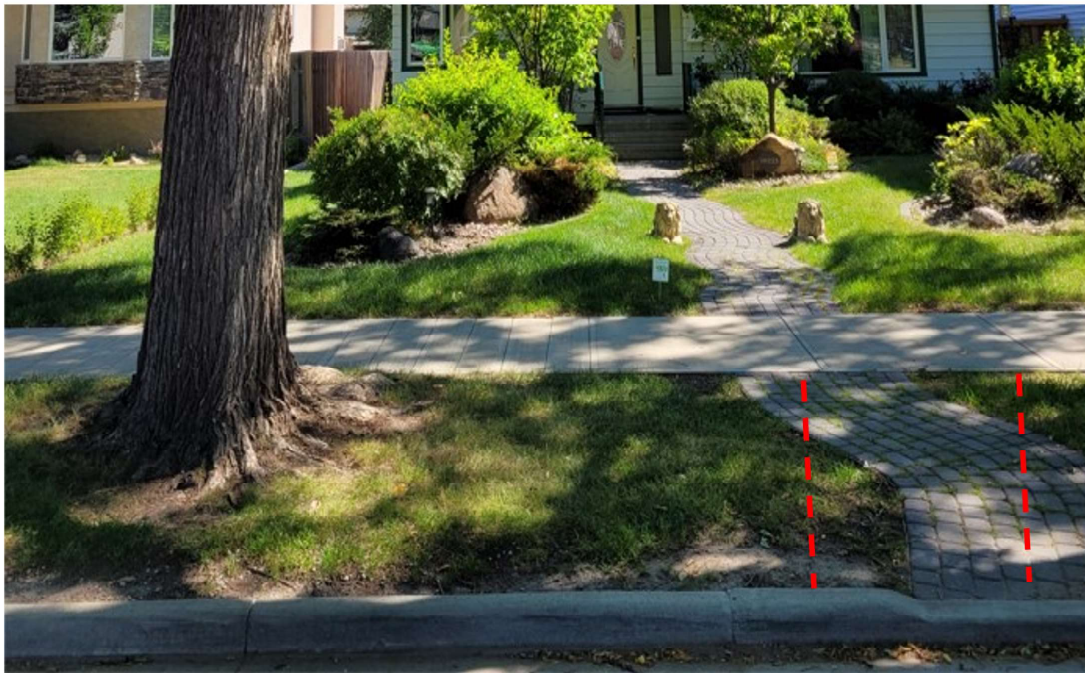
Figure 3. Approximate Location of Open Excavation.

There are no existing commercial or residential structures to be demolished. The excavation is required to repair a curb cock (CC) valve and service connection line that lies to the south of tree no 26020 between the right side of the tree trunk and patio block walkway as illustrated in **Figure 3**.

The excavation will be backfilled with a suitable inert granular and top soil material mix as soon as possible on completion of the works. The backfill will be compacted with care so as not to create an impenetrable barrier to future root elongation. The patio blocks will be reinstalled to the same dimensions as prior to the excavation.

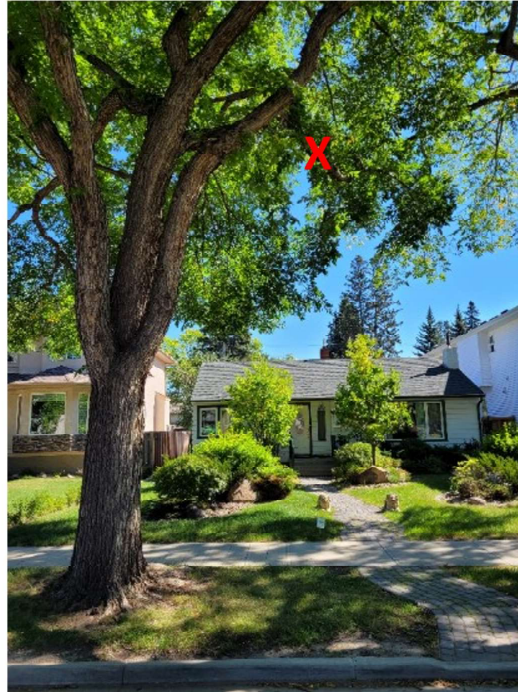
Figure 4. Location of South Side Codominant Stem to be Pruned – Tree No 26020.

As the combo-vac truck height is about 5.0 meters, the tree crown on the south side of tree 26020 will be pruned prior to excavation operations – see **Figure 4**.

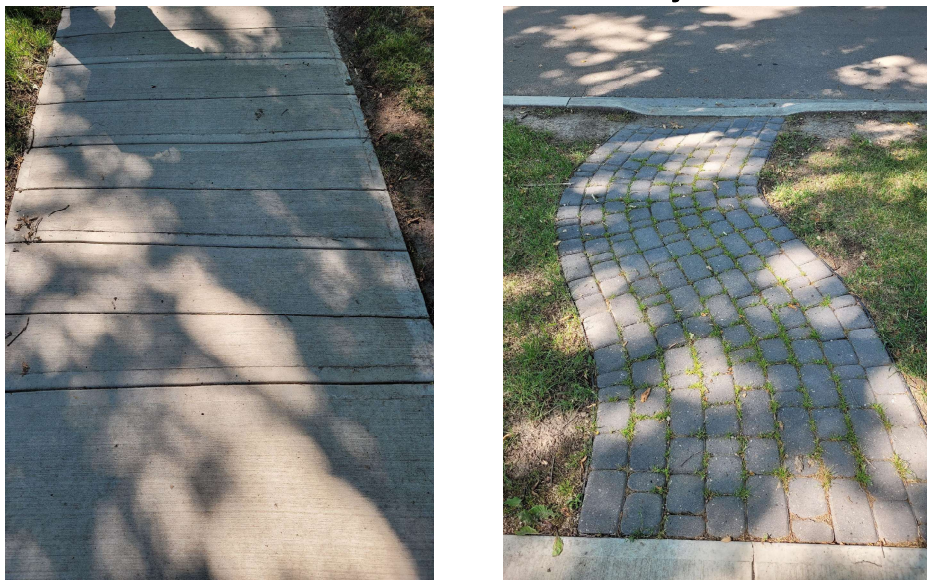
The boulevard trees are positioned on flat topography. There is a new sidewalk to the east and patio block walkway to the south of Tree No 26020.

Figure 5. New Sidewalk to East and Patio Walkway South of Elm Tree.

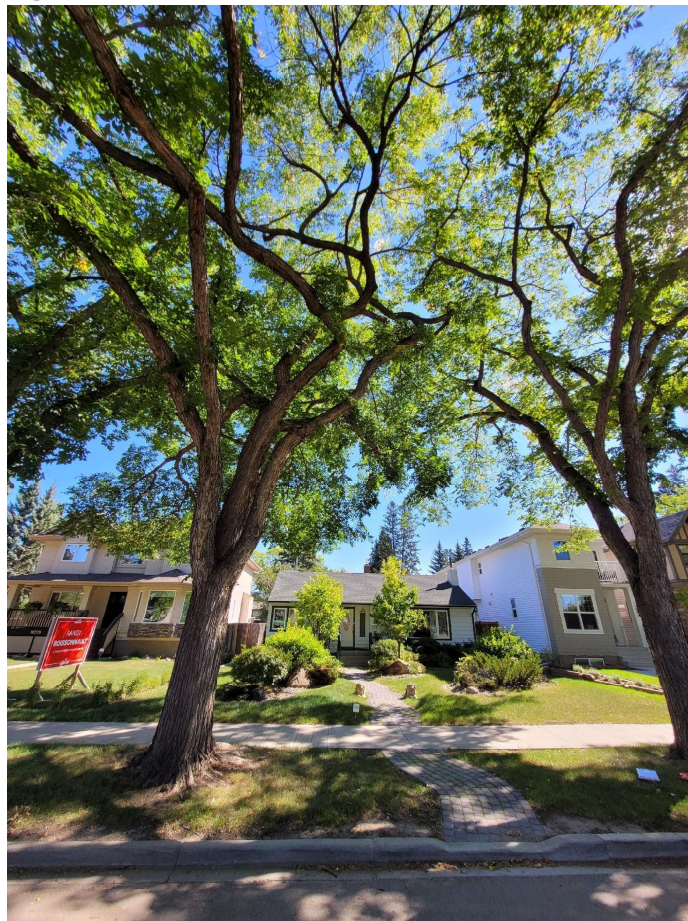
Figure 6. View from the West of Tree No 26020.

This is a mature American elm (*Ulmus americana*) that lies to the north of the proposed excavation.

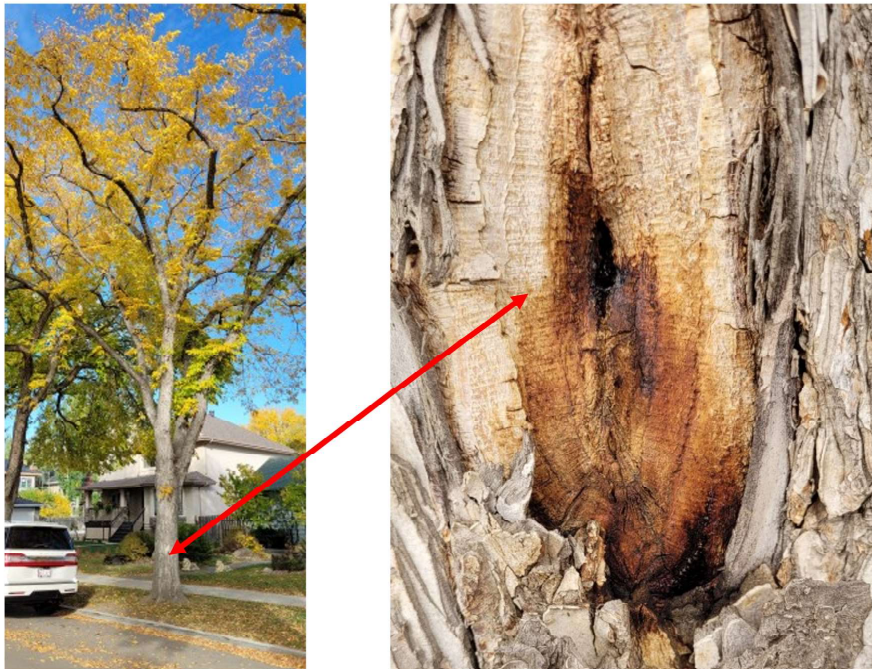
There is also a mature American elm (*Ulmus americana*) that lies to the south of the proposed excavation. The crown is well developed to the east and extends to 8.5 meters. There was evidence of “bacterial wetwood” or “slime flux” caused by the bacterium, *Enterobacter cloacae*. This bacterial species invades the stem and branch wounds causing infection in the inner sapwood and outer heartwood. The bacteria grow inside the tree wound, using tree sap as its source of nutrients. In the Figure to the right below, the tree has tried to compartmentalize and close off the wound.

**Figure 7. View of Trunk from the West of Tree No 26018
(Note photo taken September 26, 2021).**

At the time of the assessment, there was only the presence of bacterial wetwood on Tree No 26018. No other insects or disease agents were noted.
