Jasper Avenue - 110 Street to 109 Street • Looking West

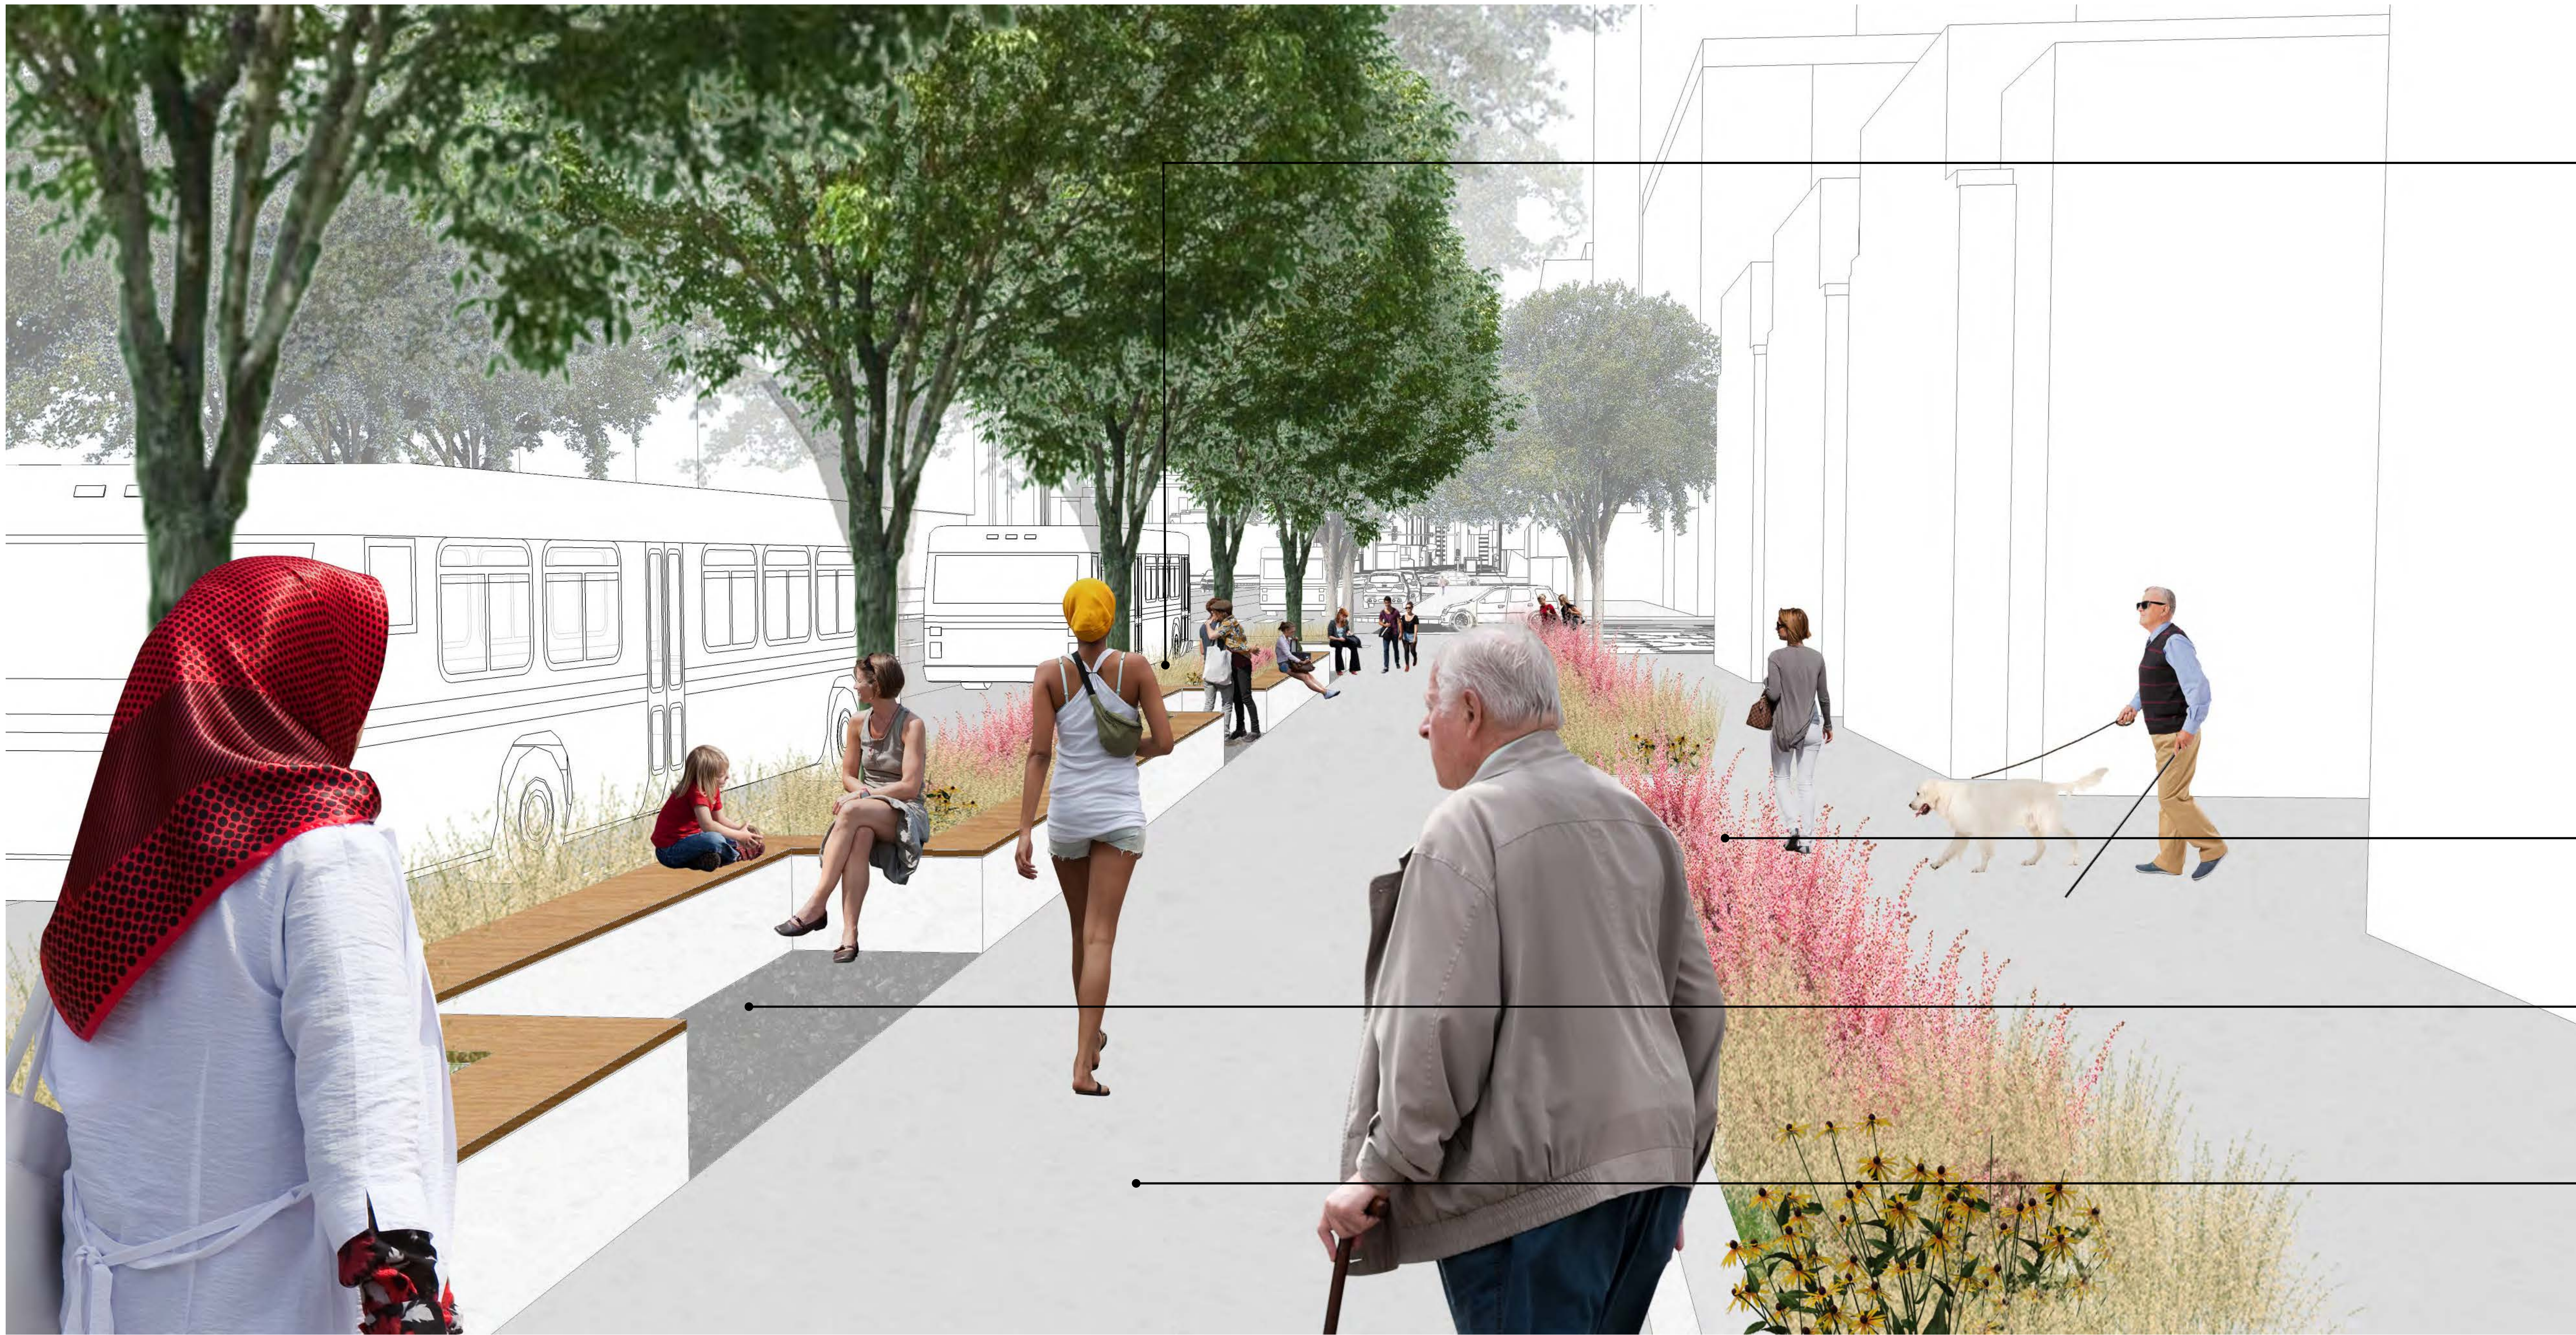
GATEWAY BLOCK

Open planting bed with street trees and ornamental planting creates a landscaped gateway to the Oliver neighborhood. Seating alcoves provide opportunity for gathering.

Replace plant material in existing planters.

High contrast paving through furnishing zone to improve wayfinding for the visually impaired.

3.0m (10') Wide concrete walk (pedestrian through zone).

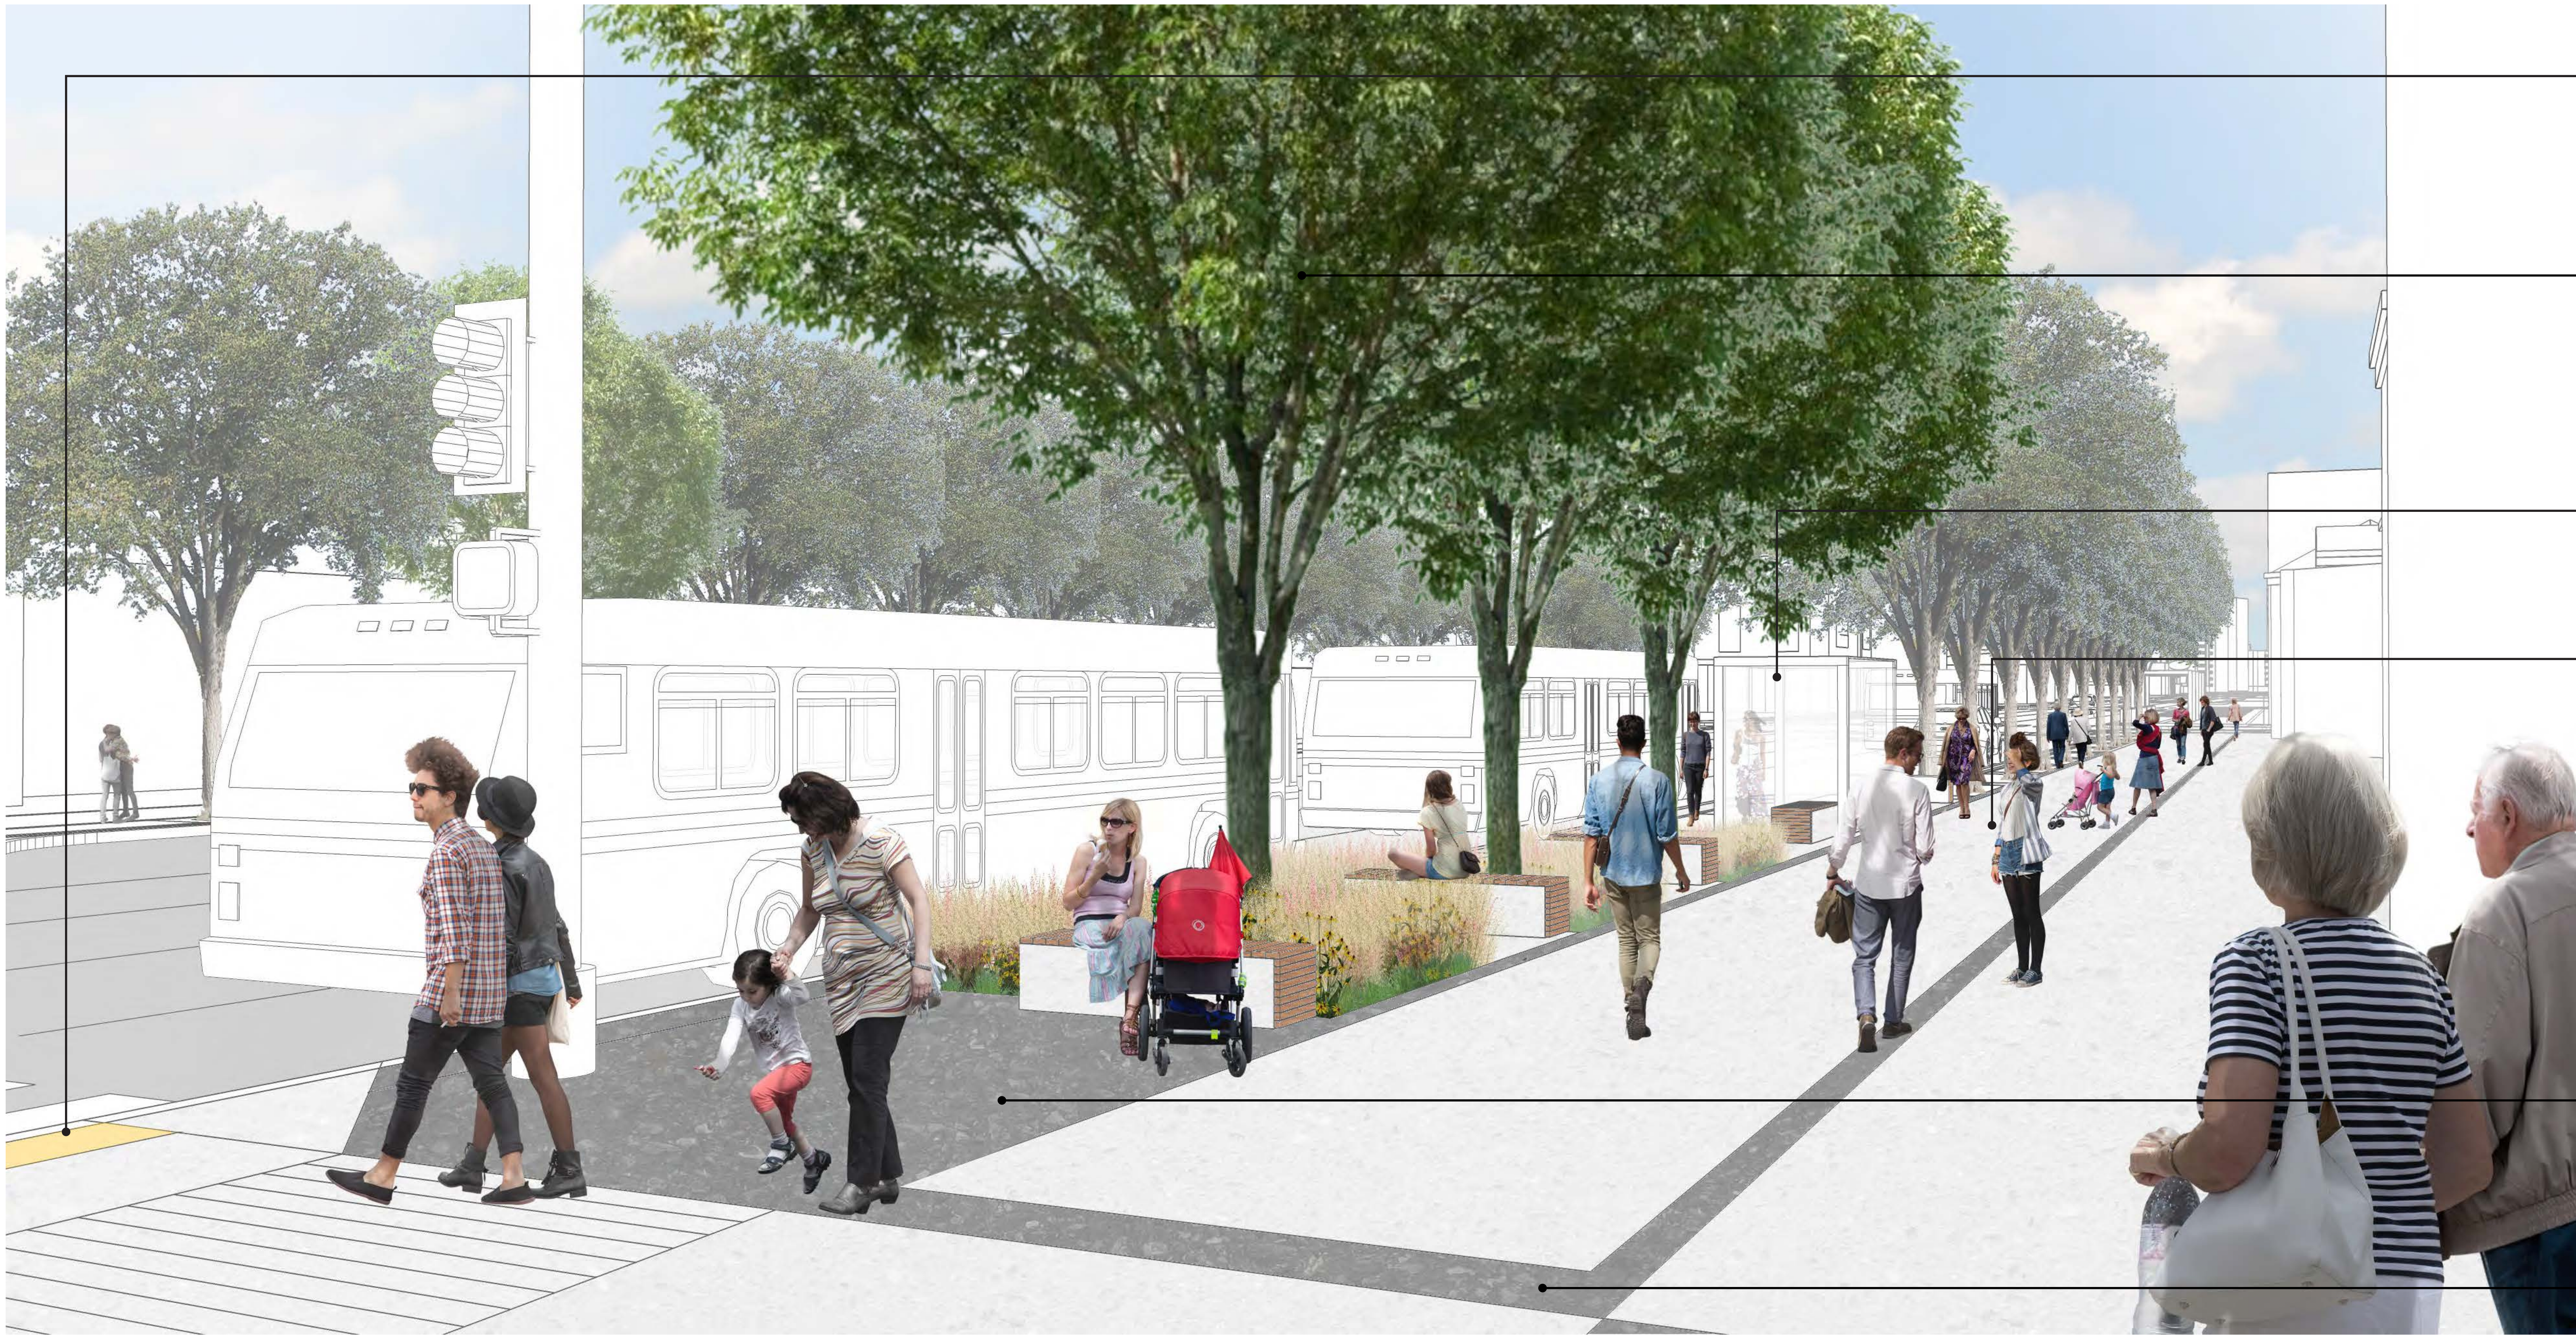
TYPICAL TRANSIT ZONE

Tactile pavers at each curb ramp to improve safety for the visually impaired.

Street trees in planting beds. Ornamental planting provides additional colour to street and interest for waiting transit riders. Benches provided for additional seating at bus stop.

Transit Zone with Shelter.

3.0m (10') Wide concrete walk (pedestrian through zone).

Space provided at corner bulbs for queuing pedestrians, traffic signal poles, and furnishings such as litter receptacles and bike racks.

High contrast paving to improve wayfinding for the visually impaired.

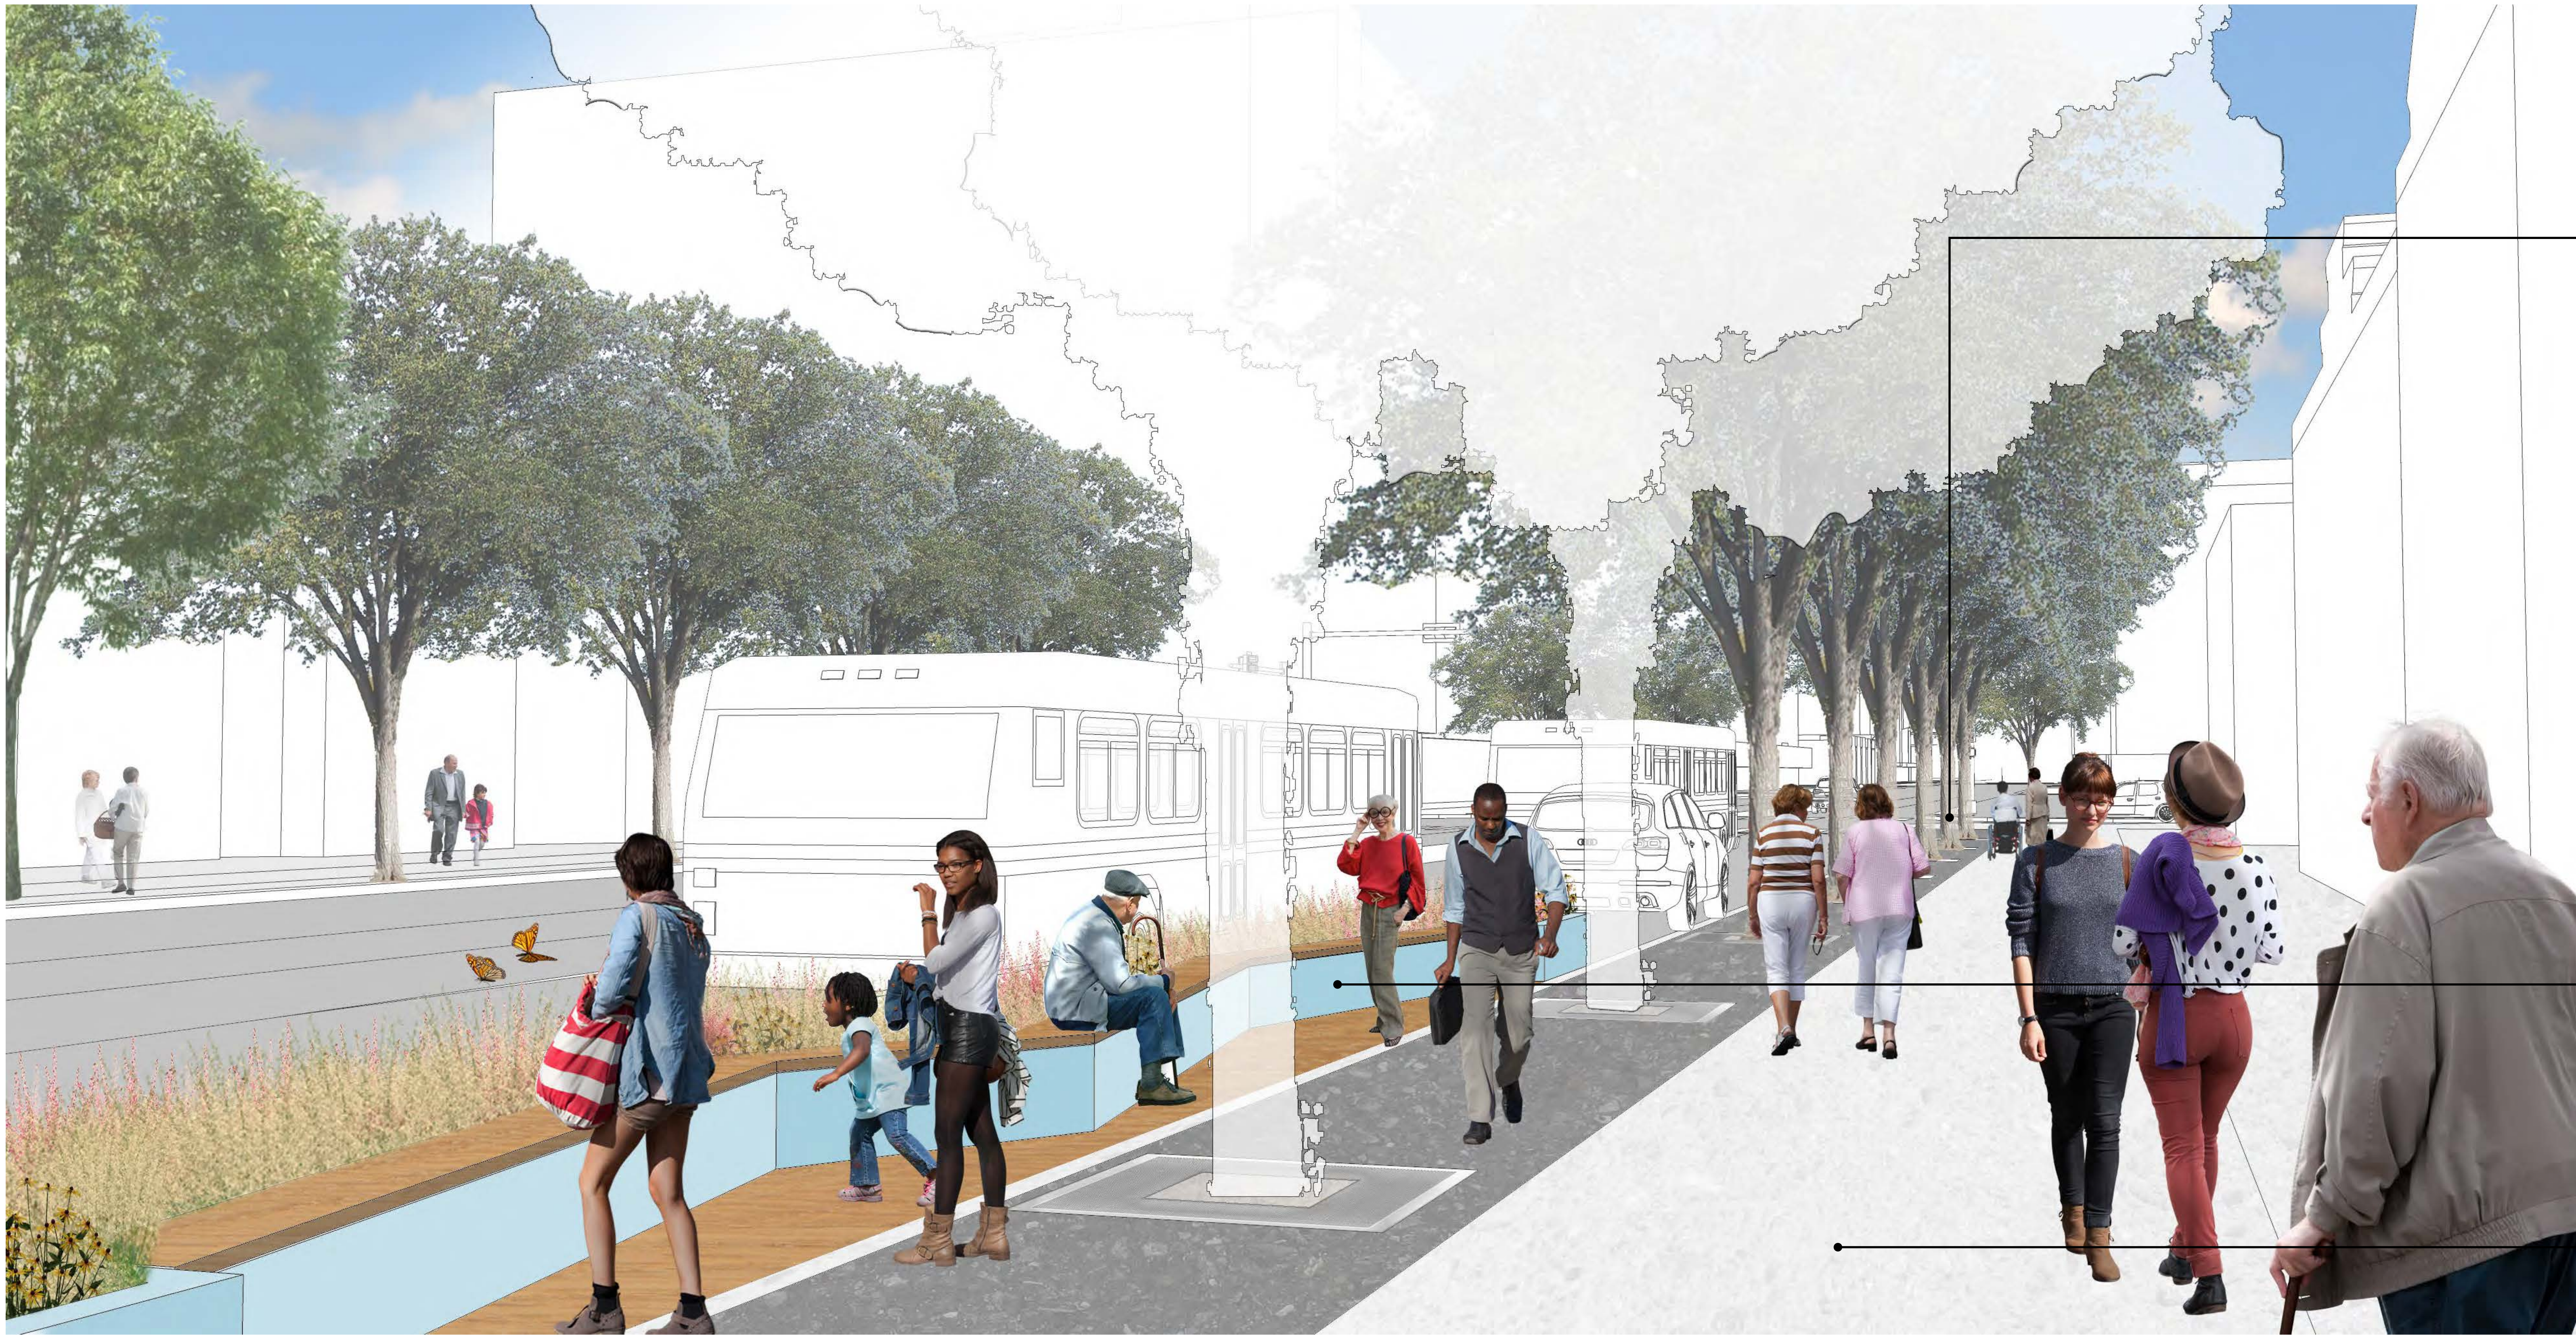
FLEX SPACE CONCEPT • SHOWING POTENTIAL PARKLET AND PARKING

FURNISHING ZONE

- Trees in grates to provide additional circulation space
- Location for furnishings and street elements such as light poles, parking pay stations, bike racks, benches, litter receptacles, signage, etc.

Flex Space provides opportunities for patios spaces, parklet installations and parking.

3.0m (10') Wide concrete walk (pedestrian through zone).

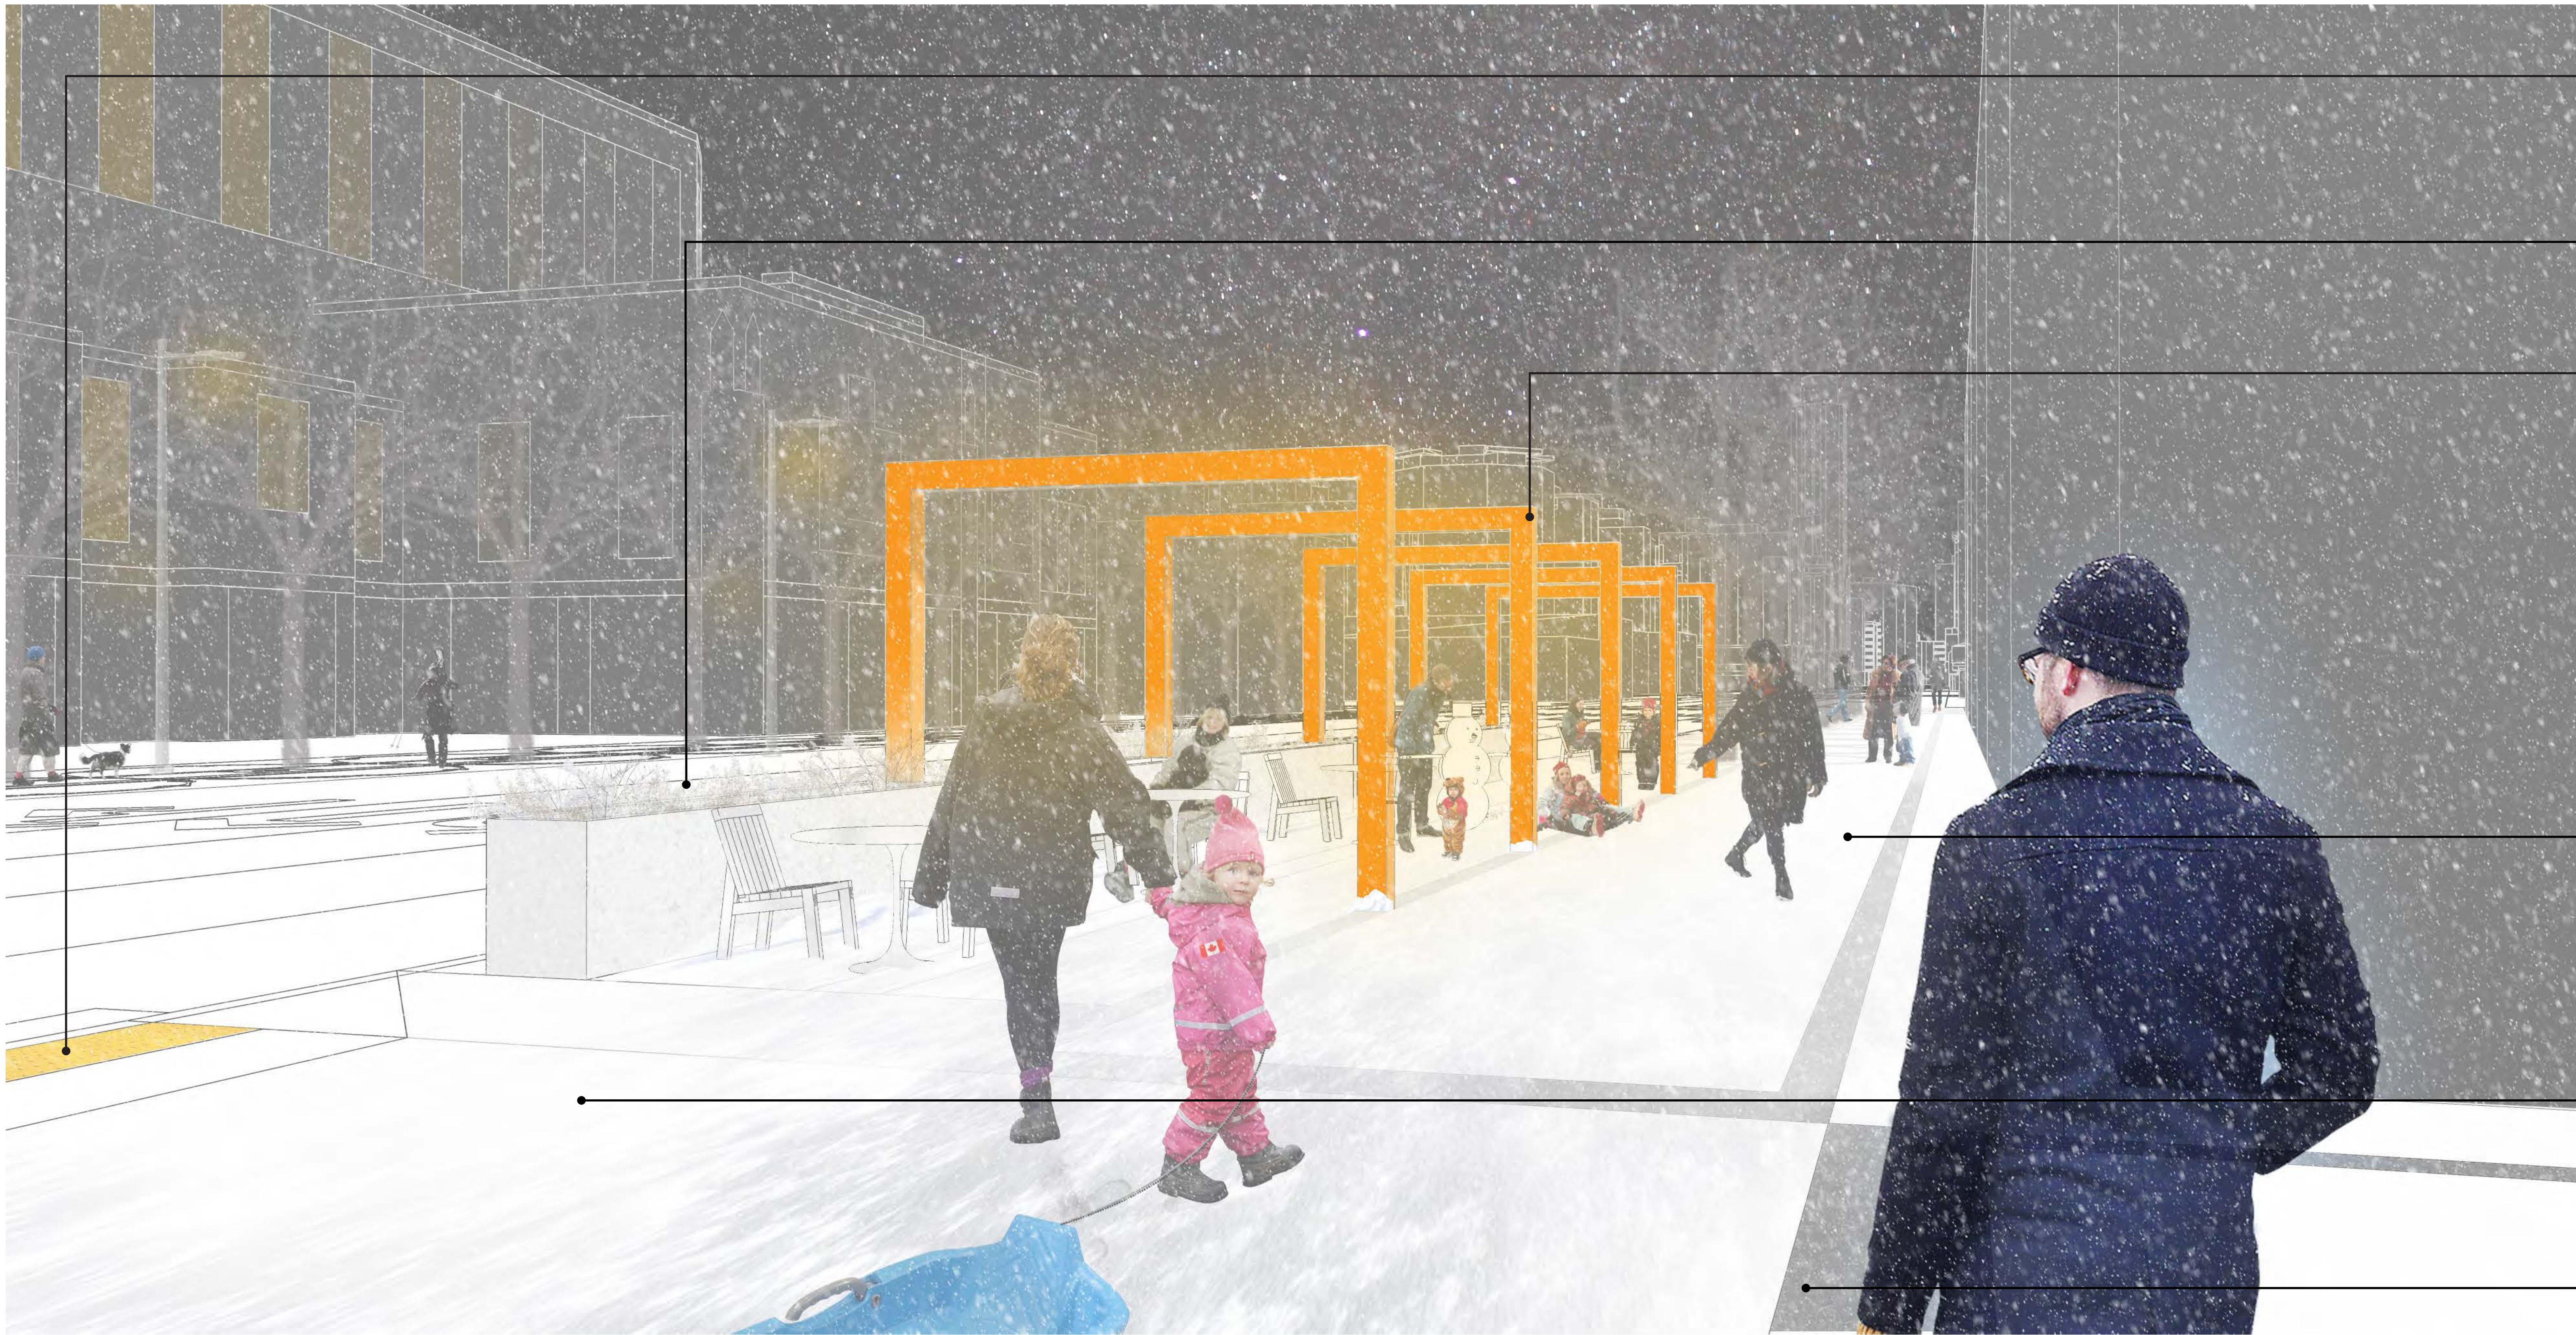
TYPICAL COLOURED FRAMES (WINTER TIME)

Tactile pavers at each curb ramp to improve safety for the visually impaired.

Raised planters for year-round display opportunities and to protect pedestrians from vehicle traffic.

Brightly coloured frames to shape gathering spaces, provide shade, lighting opportunities, year-round colour and vibrancy.

3.0m (10') Wide concrete walk (pedestrian through zone).

Space provided at corner bulbs for queuing pedestrians, traffic signal poles, and furnishings such as litter receptacles and bike racks.

High contrast paving to improve wayfinding for the visually impaired.

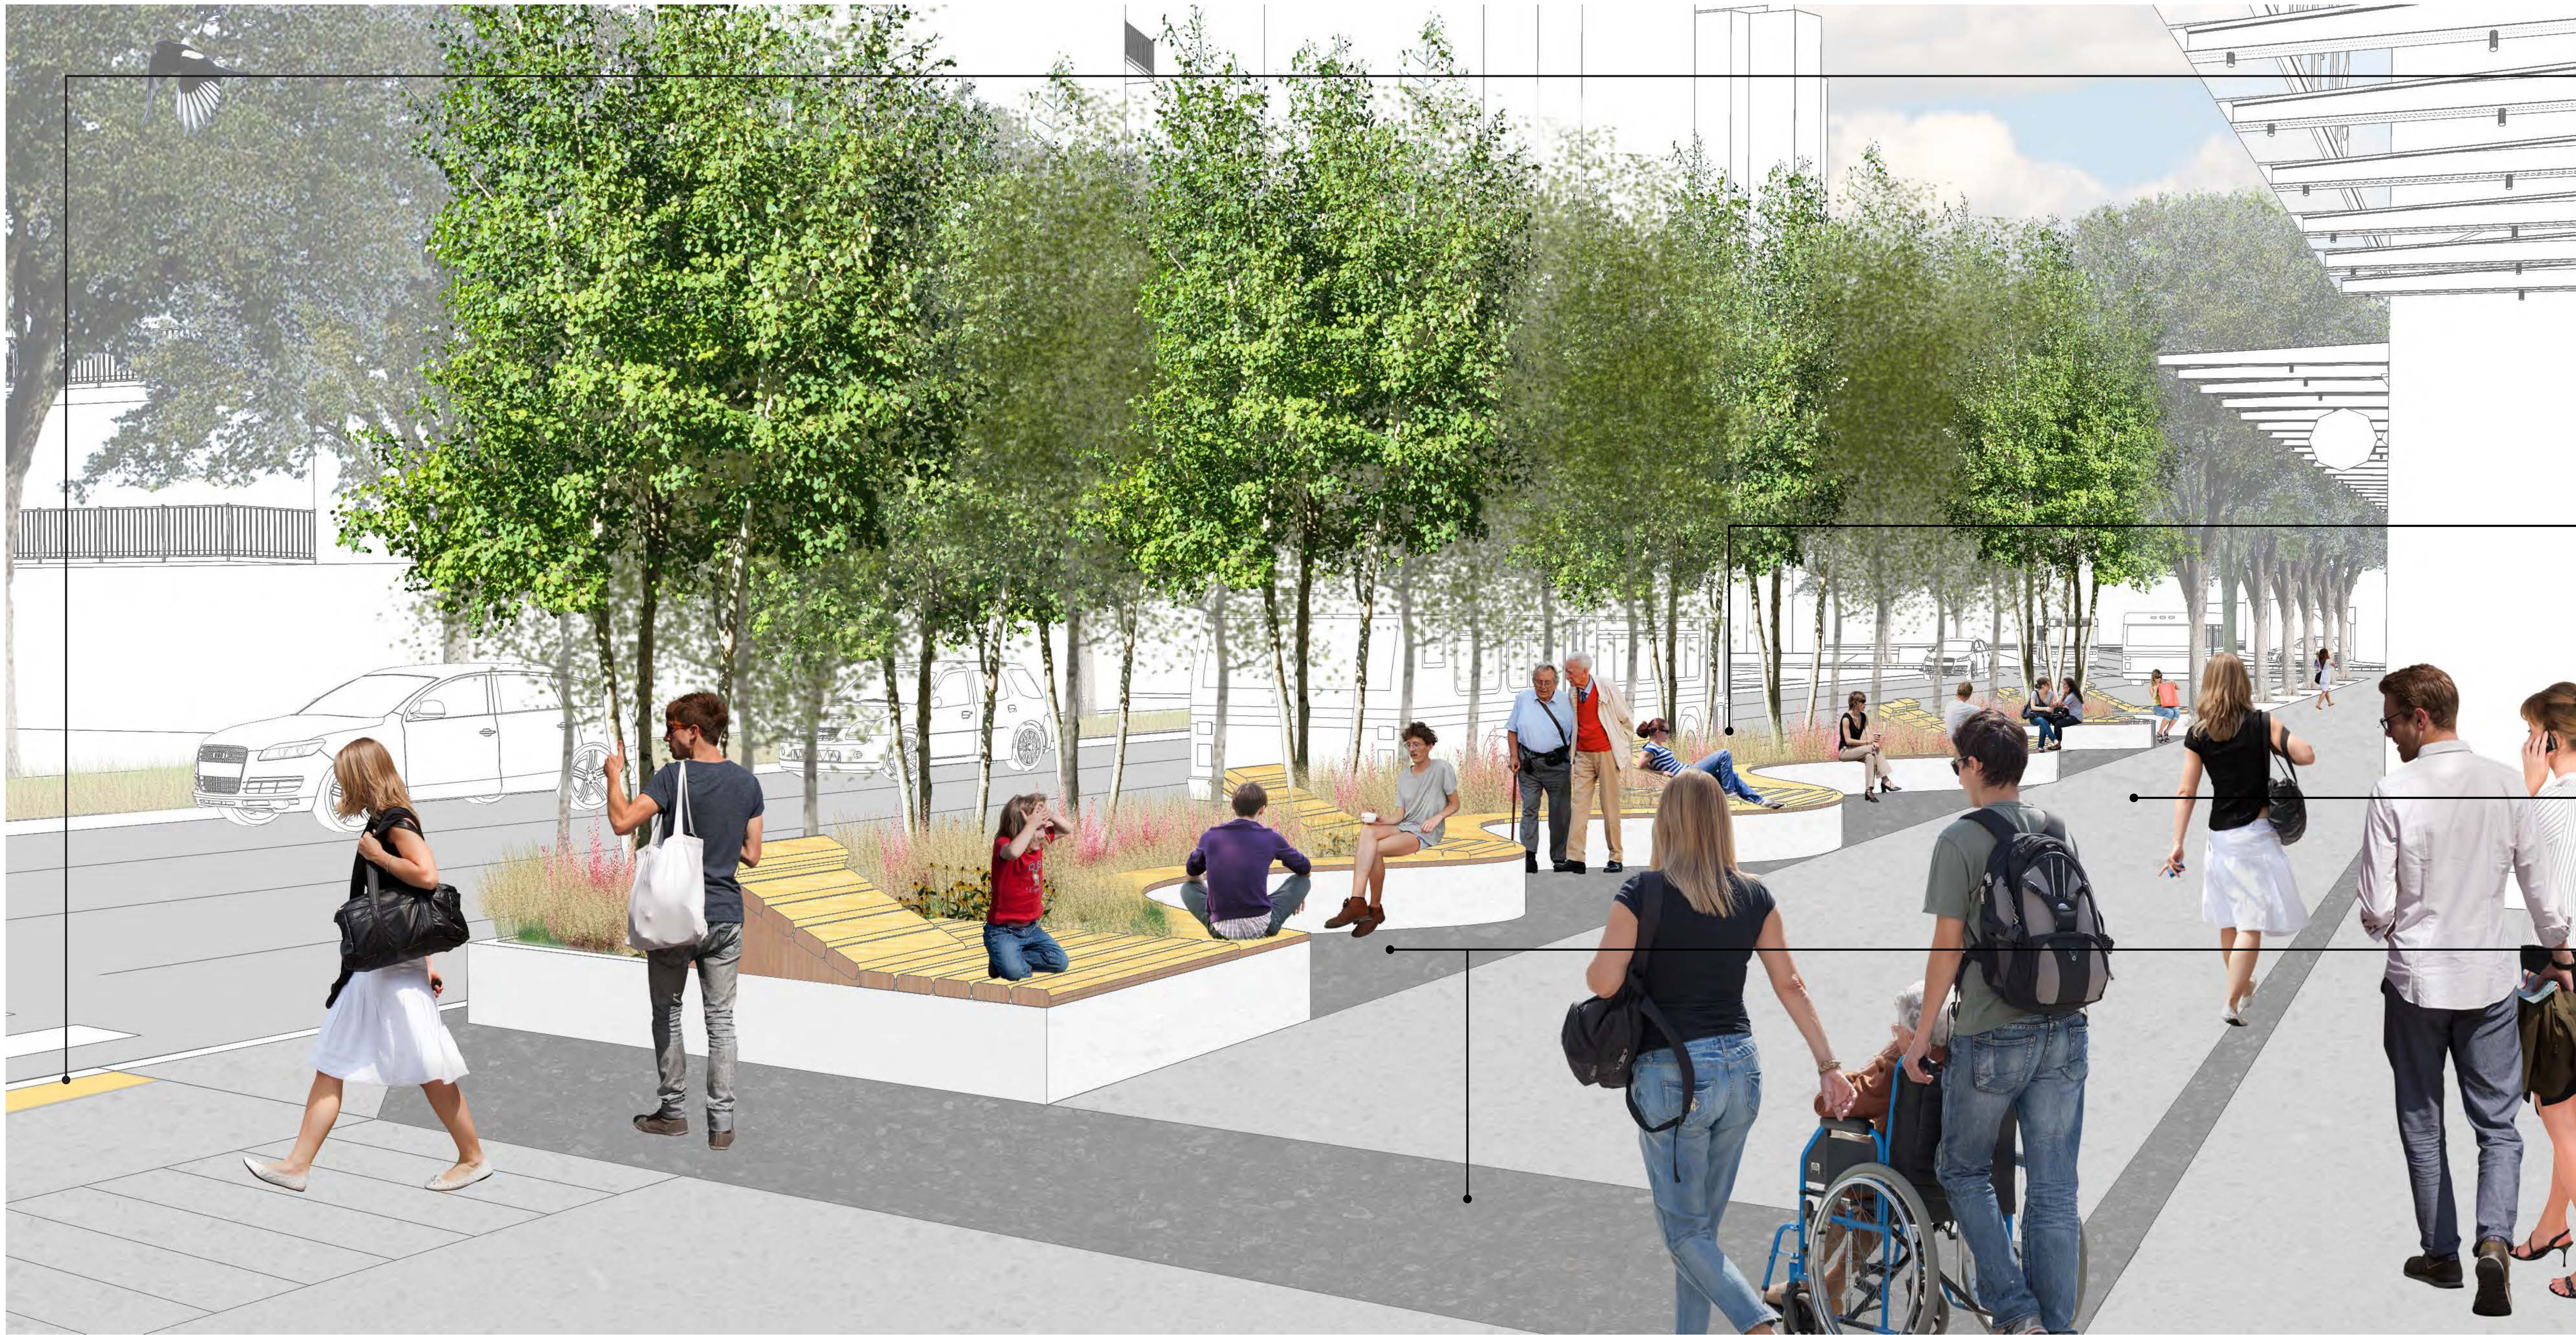
NEIGHBOURHOOD RESIDENTIAL BLOCK

Tactile pavers at each curb ramp to improve safety for the visually impaired.

PLANTING BED WITH TREE STAND AND SEATING WALL

- Configuration of seating creates distinctive gathering spaces of different sizes.
- Dense planting provides buffer from traffic.

3.0m (10') Wide concrete walk (pedestrian through zone).

High contrast paving through furnishing zone and at intersections to improve wayfinding for the visually impaired.
