6.0 HMEP ENTRANCE

6.1 Context

Adding the small parcel at Henrietta Muir Edwards Park (HMEP) entrance, totaling approximately 763 m² in area, represents a minimal addition to the overall river valley project area for the Valley Line LRT. This small project component is bordered by the previously approved Project Area to the north, east and west, with 98 Avenue situated to the south (Figure 2.1c). This area consists of manicured and un-manicured lawn, one manicured planted bed and one naturalized planted bed which includes planted trees. These lands will be available to Project Co for general construction activities and may be used to access or egress the Lands north to the river.

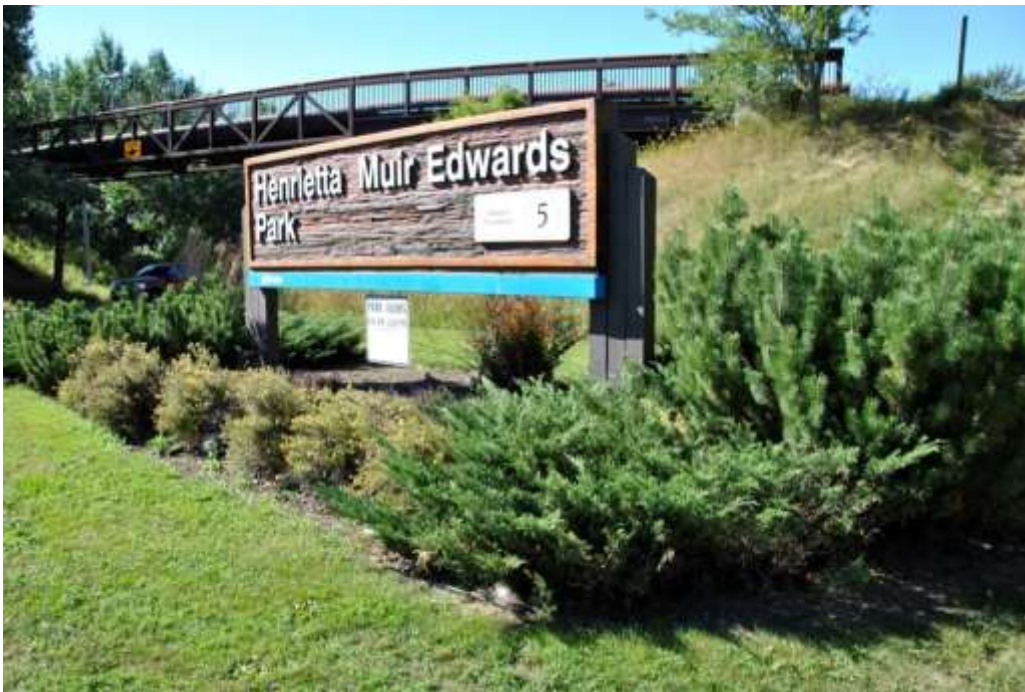
Vegetation within the proposed parcel includes manicured and non-manicured areas (Figure 5.2). Two planted beds are present: the first, in the southeast corner of the area, is manicured and includes junipers and pine shrubs (Plate 6.2), the second, in the north ends of the area, has naturalized and includes mature poplars with Manitoba maple shrubs interspersed throughout (Plate 6.3). Lands immediately around the planted beds consist of manicured lawns. Immediately west of the manicured planted bed is the constructed embankment associated with the 98 Avenue Pedestrian Bridge. No mowing appears to be conducted in this area likely due to the steep slope; vegetation consists of a mix of grass and weedy species with some small shrub saplings (Plate 6.4).

Plate 6.2. HMEP near the north end of the 98 Avenue Pedestrian Bridge looking northeast; planted bed with park entrance sign, looking southwest (Sept 2014).

The entrance sign to HMEP, situated within the planted bed, will require temporary removal in support of construction activities within the project component area. Prior to the initiation of construction, the City has committed to removing the above-ground portion of the sign. Project Co will then be responsible for removing and replacing the sign base. The original entrance sign to HMEP would then be reinstalled by the City on the new base. Project Co will notify the City at least 90 days prior to the planned removal of the sign base to permit adequate time for the City to remove the sign. Implementation of these measures will ensure that any long-term impacts will be mitigated and, therefore, negligible. The short-term loss of a park entrance sign is considered negligible given the construction that will be occurring in this area of the park and the temporary unavailability of the trailhead parking lot.

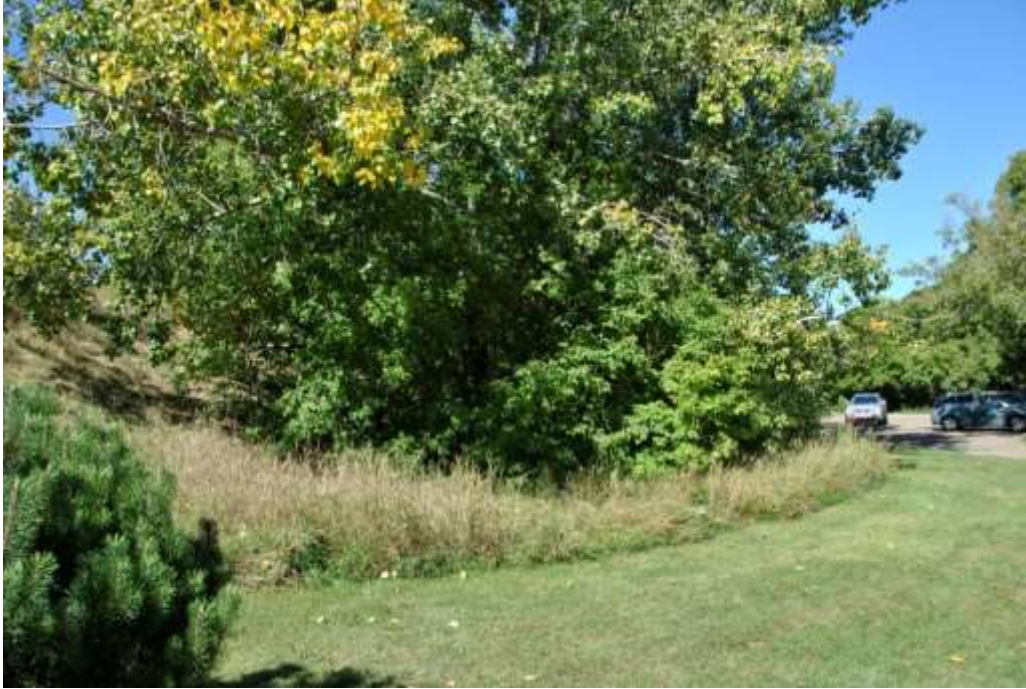
Plate 6.3. HMEP entrance looking northeast; mature poplar and Manitoba maple stand, (Sept. 2104).

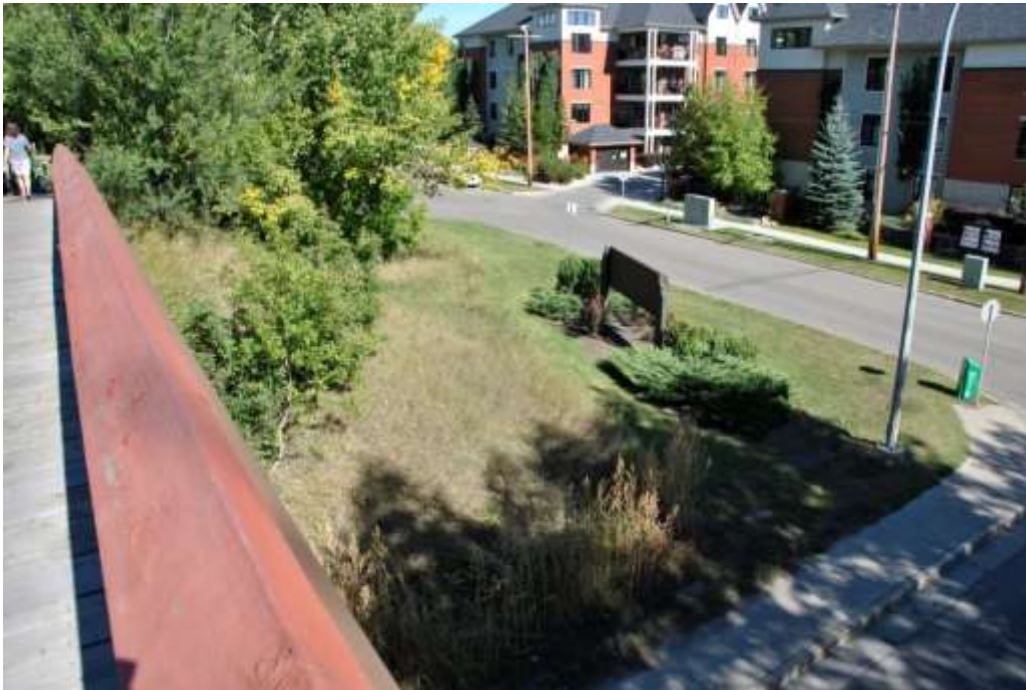
Plate 6.4. HMEP entrance looking northeast; unmowed grasses on the pedestrian bridge embankment (Sept. 2014).
